Southwest Property Inspection

Property Inspection Report

123 ABC Dr.
San Diego, CA 92067

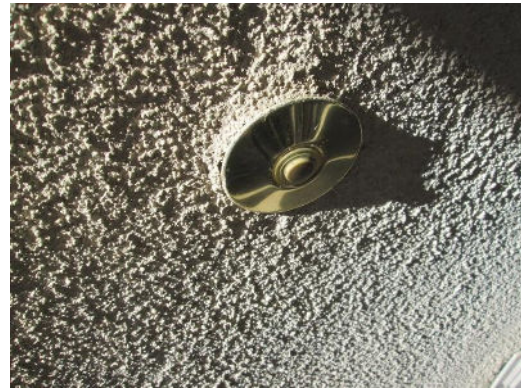
4. ☐ ☐ ☒ ☐ Door Bell: The doorbell is inoperative. Repairs by a qualified licensed contractor are recommended.

1. Door Bell: The doorbell is inoperative. Repairs by a qualified licensed contractor are recommended.
2. Patio Doors: Vinyl slider with dual-pane glass The patio screen doors are missing. Recommend replacement. Repairs by a qualified licensed contractor are recommended.

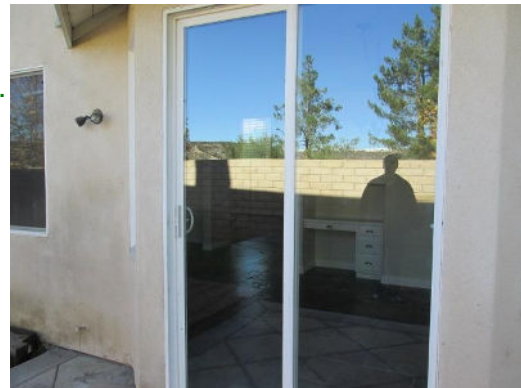
6. ☐ ☐ ☒ ☐ Patio Doors: Vinyl slider with dual-pane glass The patio screen doors are missing. Recommend replacement. Repairs by a qualified licensed contractor are recommended.

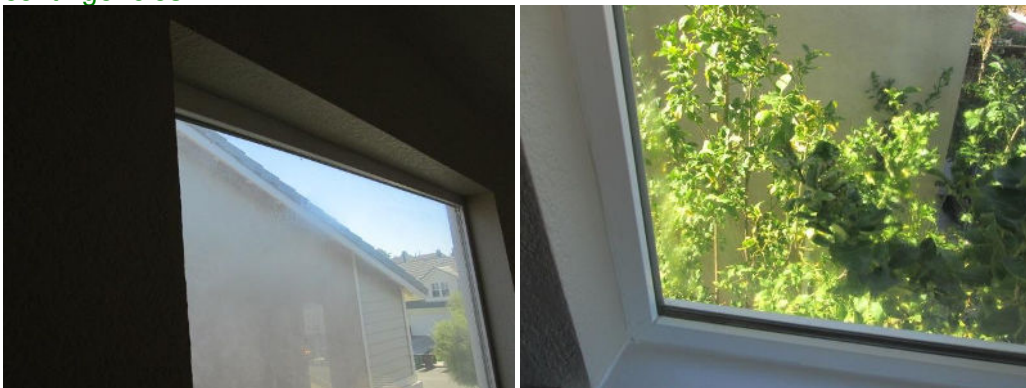
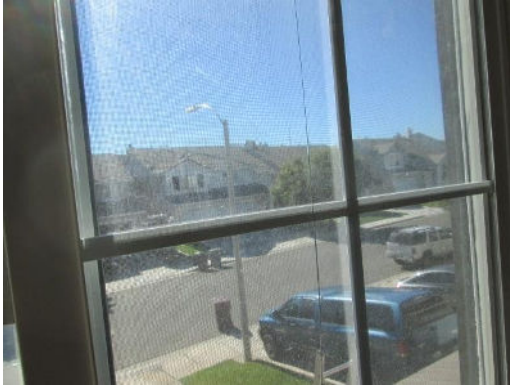
7. ☐ ☐ ☒ ☐ Windows: Moisture and fogging were noted in the dual-pane glass of the windows in the following locations: 2nd floor master, 2nd floor guest bedroom and over open area above (Defective hermetic seals.) Repairs by a qualified licensed window contractor are recommended. Note: Due to climatic conditions, the nature of the components, and the cleanliness of the glass, it is not possible to determine all of the failures present. Evaluation of the remaining windows in the home by a qualified licensed glazing contractor is recommended prior to removal of purchase contingencies.

3. Windows: Moisture and fogging were noted in the dual-pane glass of the windows in the following locations: 2nd floor master, 2nd floor guest bedroom and over open area above (Defective hermetic seals.) Repairs by a qualified licensed window contractor are recommended.
Note: Due to climatic conditions, the nature of the components, and the cleanliness of the glass, it is not possible to determine all of the failures present. Evaluation of the remaining windows in the home by a qualified licensed glazing contractor is recommended prior to removal of purchase contingencies.

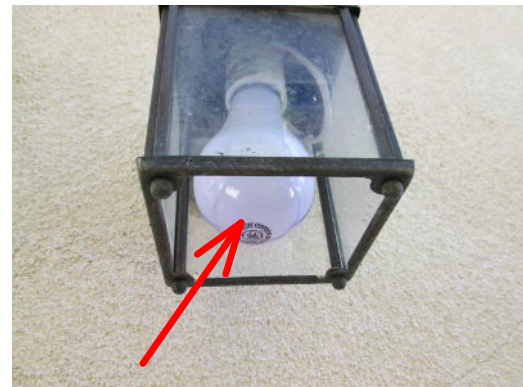
8. ☒ ☐ ☐ ☐ Window/Door Screens:
 9. ☐ ☐ ☒ ☐ Exterior Lighting: Loose wiring and bulb assembly side of garage. Repairs by a qualified licensed electrician are recommended.

4. Exterior Lighting: Loose wiring and bulb assembly side of garage. Repairs by a qualified licensed electrician are recommended.

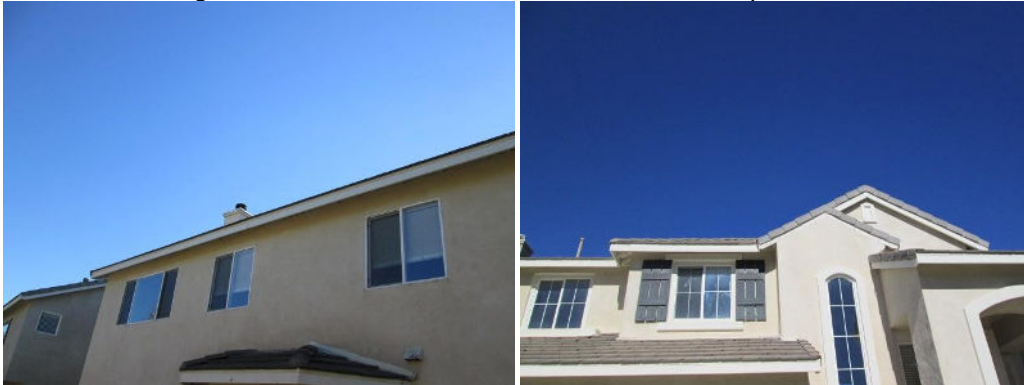
2. ☒ ☒ ☐ ☐ Unable to Inspect: 75% Note: The 2nd story roof was inaccessible due to its height. A limited visual inspection was done from the ground using binoculars. Unseen defects may exist. A qualified licensed roofing contractor should be consulted for a complete evaluation.

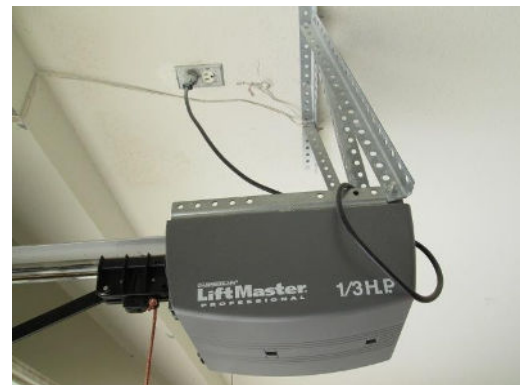
4. ☐ ☐ ☐ ☒ Door Opener: Lift Master The pressure sensor safety reversing system on the garage door opener requires adjustment. The door does not reverse when an object blocks its path- Safety hazard. Repairs by a qualified licensed garage door contractor are recommended.

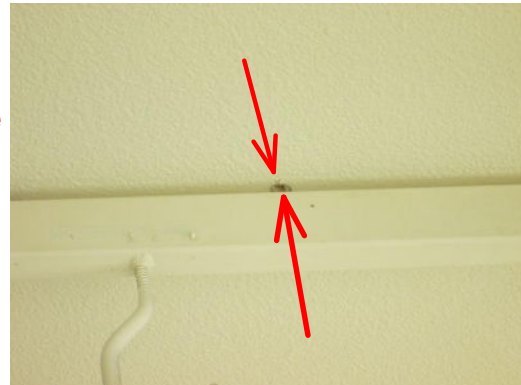
8. ☐☐☐☒ Ceiling: Drywall There are unrepaired holes in the garage ceiling causing a breach in the fire-resistant-rated assembly between the garage and the house- Fire hazard. There is an unrepaired hole in the garage ceiling causing a breach in the fire-resistant-rated assembly between the garage and the house- Fire hazard.

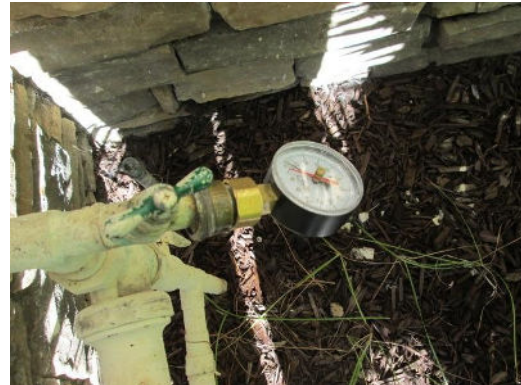
3. ☐ ☐ ☒ ☐ Water Pressure: 100 PSI The water pressure is excessive. Excessive water pressure can cause damage and leaks at the plumbing components. Recommend having a qualified licensed plumber reduce the water pressure to 40 - 80 PSI.

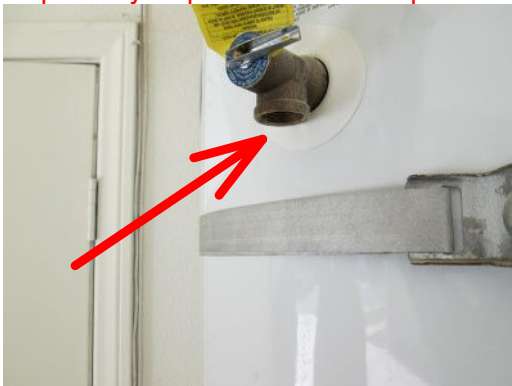
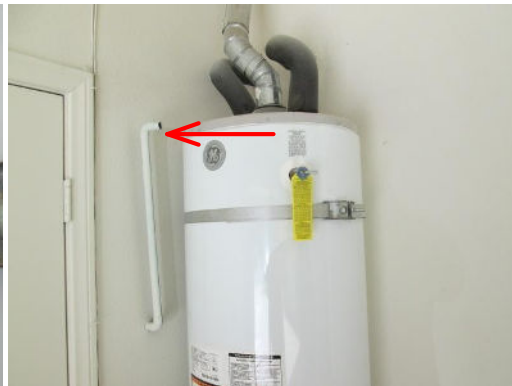
13. ☐ ☐ ☐ ☒ TPR Valve/Discharge Line: The TPR valve does not have a discharge line installed- Safety hazard. Repairs by a qualified licensed plumber are recommended.

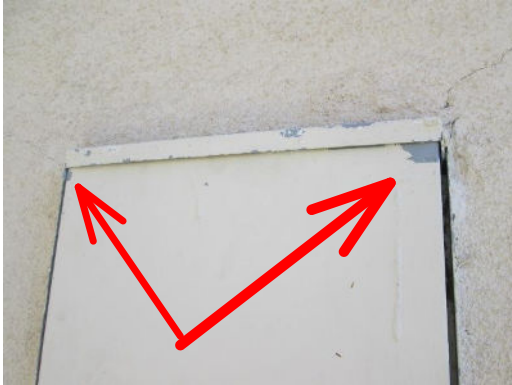
12. ☐ ☐ ☐ ☒ Manufacturer: Cutler-Hammer **The hinges are loose on the electric panel cover. The cover falls off. Water entry may occur. Fire/Shock hazard. Repairs by a qualified licensed electrician are recommended.**

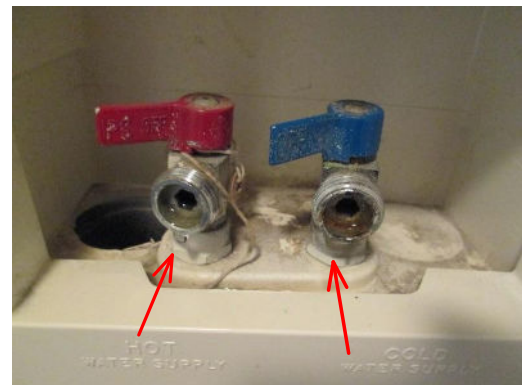
- 1. ☒ ☐ ☐ ☐ Ceiling: Drywall
- 2. ☒ ☐ ☐ ☐ Walls: Drywall
- 3. ☒ ☐ ☐ ☐ Floor: Tile
- 4. ☒ ☐ ☐ ☐ Electrical:
- 5. ☐ ☐ ☒ ☐ Washer Hose Bib: The hot and cold water valves are leaking. Repairs by a qualified licensed plumber are recommended.

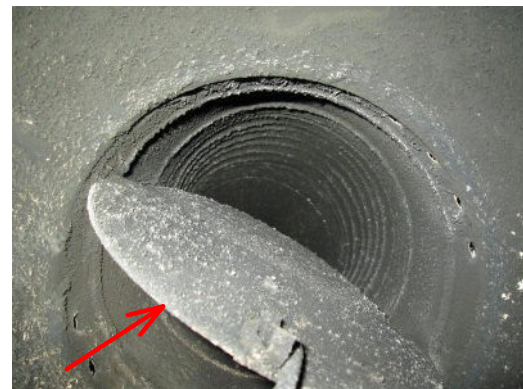
1. ☒ ☐ ☐ ☐ Fireplace Construction: Factory built
2. Type: Gas log
3. ☒ ☐ ☐ ☐ Smoke Chamber: Metal
4. ☒ ☐ ☐ ☐ Flue: Metal Not fully visible.
5. ☐ ☐ ☐ ☒ Damper: Metal **A damper clamp is not installed in the fireplace- Safety hazard. The damper is required to be permanently blocked open in fireplaces containing a gas fixture to prevent gas leaks from entering the home. Installation by a qualified licensed contractor is advised.**

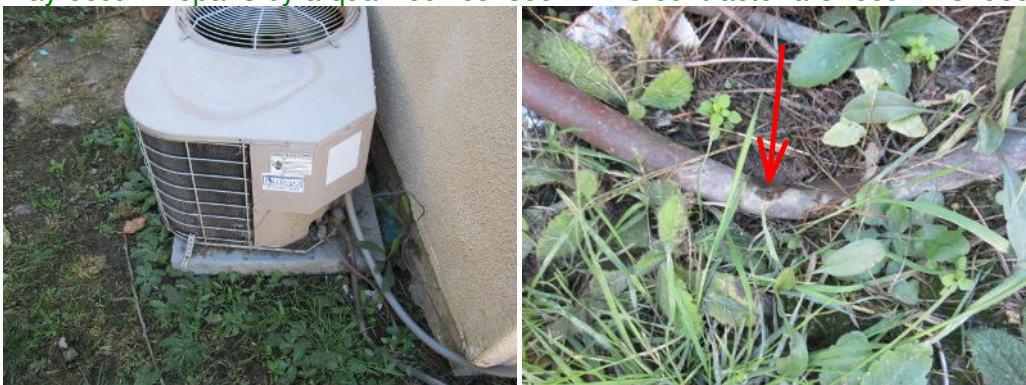
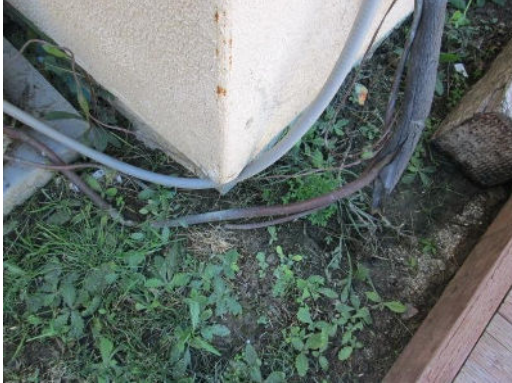
9. ☐ ☐ ☒ ☐ A/C System Operation: Functional The A/C refrigerant line is crimped. Reduced system efficiency may occur. Repairs by a qualified licensed HVAC contractor are recommended.

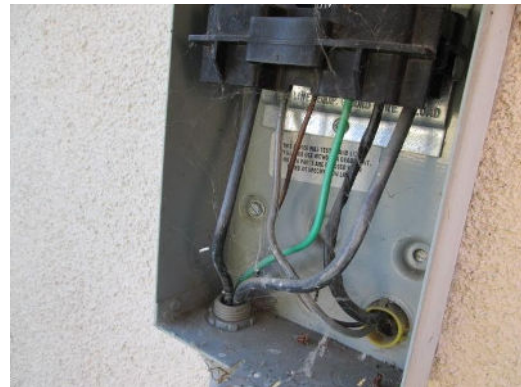
- 10. ☒ ☐ ☐ ☐ Condensate Removal: PVC
- 11. Fuel Type: 220-240 VAC Temperature Differential: 17
- 12. Type: Central A/C Capacity:
- 13. ☒ ☐ ☐ ☐ Visible Coil: Aluminum
- 14. ☒ ☐ ☐ ☐ Refrigerant Lines: Serviceable condition
- 15. ☐ ☐ ☐ ☒ Electrical Disconnect: Tumble switch The dead-front cover is missing in the electrical disconnect box at the A/C condensing unit- Shock hazard. Recommend repairs by a qualified licensed contractor.

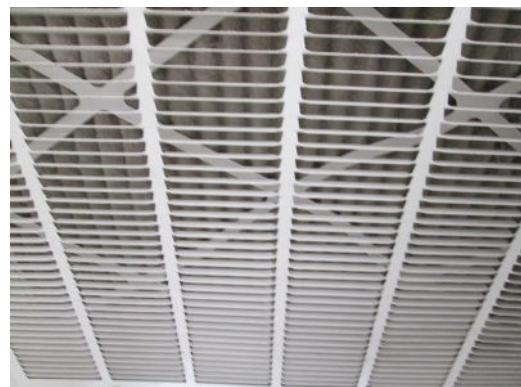
- 16. ☒ ☐ ☐ ☐ Exposed Ductwork: Insulated flex
- 17. ☐ ☐ ☒ ☐ Blower Fan/Filters: 1st floor filter missing. 2nd floor incorrect size, The furnace air filter is dirty. Reduced efficiency and shortened life-span of the unit may occur. Recommend replacement of the filters.

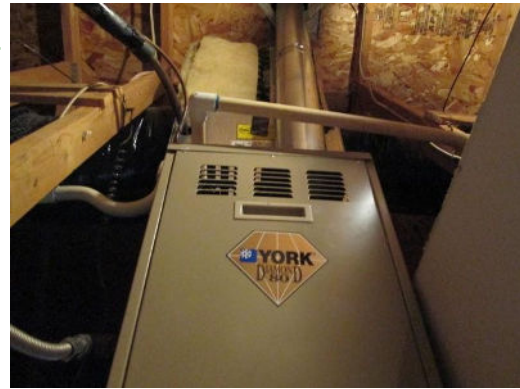
1. ☐ ☐ ☒ ☐ Heating System: Inadequate The heating system is inoperative. Repairs by a qualified licensed HVAC contractor are recommended.

10. 1st Floor Heating System Heating System: Inadequate The heating system is inoperative. Repairs by a qualified licensed HVAC contractor are recommended.

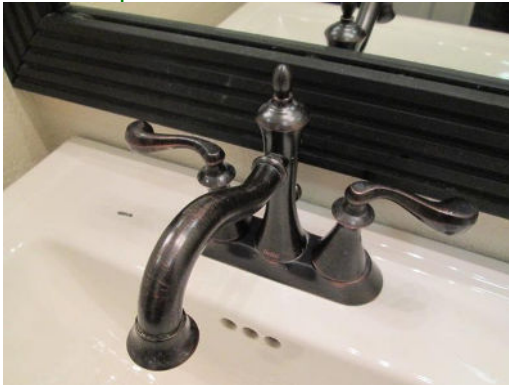
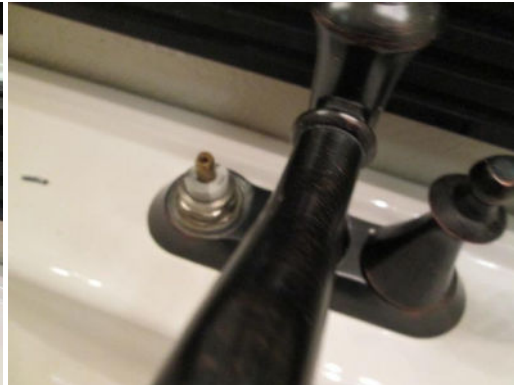
1. ☒ ☐ ☐ ☐ Ceiling:
2. ☒ ☐ ☐ ☐ Walls:
3. ☒ ☐ ☐ ☐ Floor: Stone
4. ☒ ☐ ☐ ☐ Doors:
5. ☒ ☐ ☐ ☐ Electrical: 110 VAC GFCI outlets, Lighting
6. ☒ ☐ ☐ ☐ Counter Top: Laminate and composite
7. ☒ ☐ ☐ ☐ Cabinets: Wood
8. ☒ ☐ ☐ ☐ Sinks: Pedestal
9. ☐ ☐ ☒ ☐ Plumbing/Fixtures: The sink faucet fixture is loose. Leakage may occur. Repairs by a qualified licensed plumber are recommended.

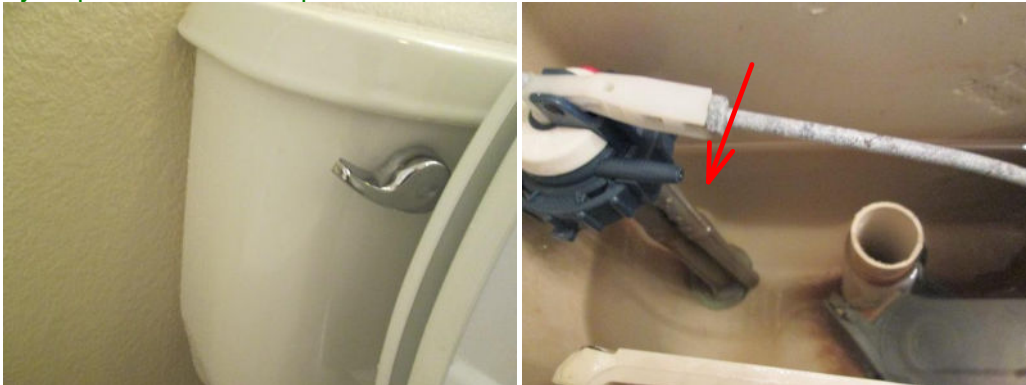
25. ☐☐☒☐ Toilet: The toilet does not flush properly. The flush assembly requires repair or adjustment. Repairs by a qualified licensed plumber are recommended.

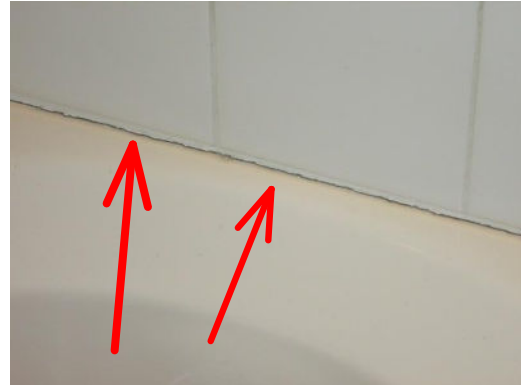
38. ☐ ☐ ☒ ☐ Tub: The caulking around the top of tub is deteriorated. Moisture penetration may occur. Repairs by a qualified licensed contractor are recommended.

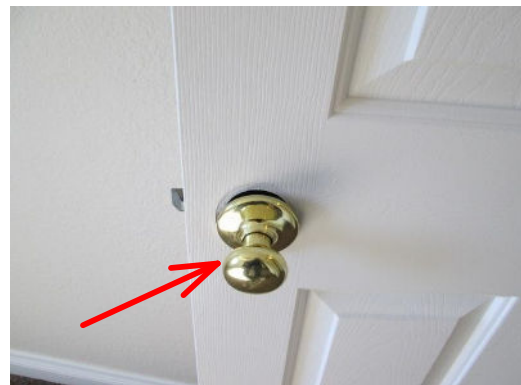
1. ☒ ☐ ☐ ☐ Closets:
 2. ☒ ☐ ☐ ☐ Ceilings: Drywall
 3. ☒ ☐ ☐ ☐ Walls: Drywall
 4. ☒ ☐ ☐ ☐ Floors: Hardwood
 5. ☐ ☐ ☒ ☐ Doors: The door hardware is loose in the 2nd floor guest bedroom, Repairs by a qualified licensed contractor are recommended.

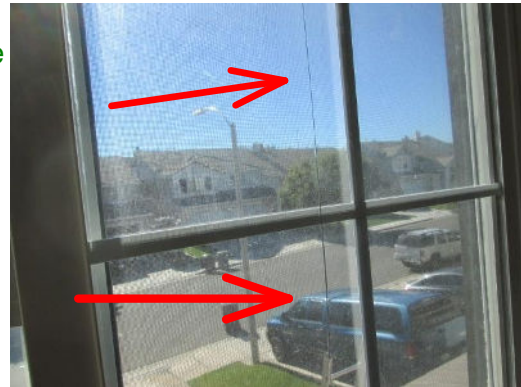
6. ☐ ☐ ☒ ☐ Windows: The window glass is cracked in the 2nd floor front guest bedroom. Repairs by a qualified window contractor are recommended.

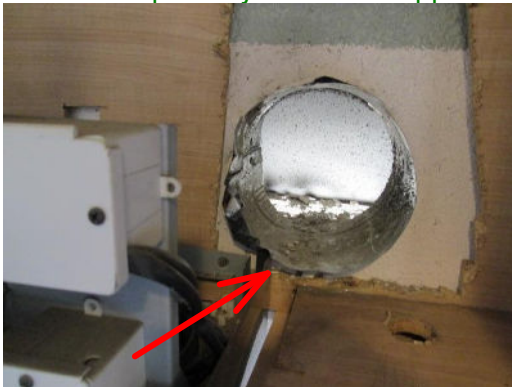
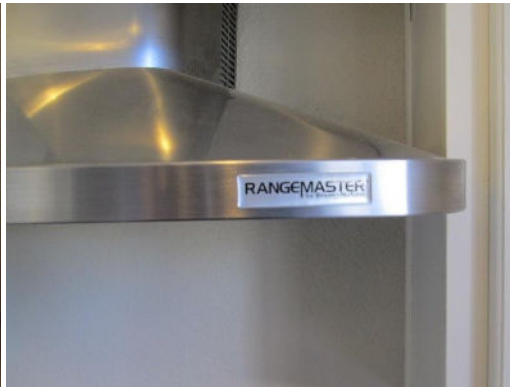
2. ☐ ☐ ☒ ☐ Ventilator: A duct for the oven exhaust fan is not installed. The exhaust air blows into the upper cabinet. Repairs by a certified appliance technician are recommended.

17. 1st Floor Kitchen Ventilator: A duct for the oven exhaust fan is not installed. The exhaust air blows into the upper cabinet. Repairs by a certified appliance technician are recommended.
18. 1st Floor Kitchen Air Gap Present? Yes Water flows out of the air gap and onto the countertop when the dishwasher drains. The knock-out at the food waste disposal may not be removed. Water damage may occur. Repairs by a qualified licensed plumber are recommended.
19. 1st Floor Kitchen Counter Top: Tile The grouting is cracked at the countertop back-splash. Water entry may occur. Re-grouting by a qualified licensed contractor is recommended.

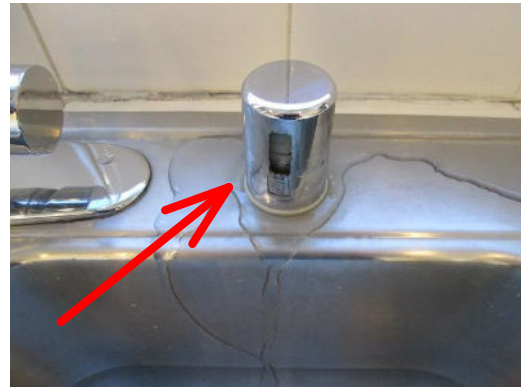
5. Air Gap Present? ☒ Yes ☐ No Water flows out of the air gap and onto the countertop when the dishwasher drains. The knock-out at the food waste disposal may not be removed. Water damage may occur. Repairs by a qualified licensed plumber are recommended.

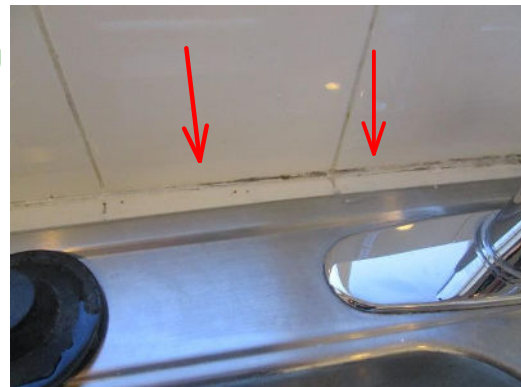
6. ☒ ☐ ☐ ☐ Sink: Stainless steel- Dual basin
 7. ☒ ☐ ☐ ☐ Electrical: 110 VAC GFCI outlets, Lighting
 8. ☒ ☐ ☐ ☐ Plumbing/Fixtures:
 9. ☐ ☐ ☒ ☐ Counter Top: Tile The grouting is cracked at the countertop back-splash. Water entry may occur. Re-grouting by a qualified licensed contractor is recommended.
